# Roof LINK<sup>®</sup>

# NZ Bus re-roofs test effectiveness

**Long before the launch of the Best Practice Guidelines for Working on Roofs by MBIE last year, Metro Roofing Ltd was ramping up its H&S measures to be fully compliant with the regulations. But a recent re-roofing contract for NZ Bus has fully tested the effectiveness of the company's \$235,000 investment in health and safety over the last four years.**

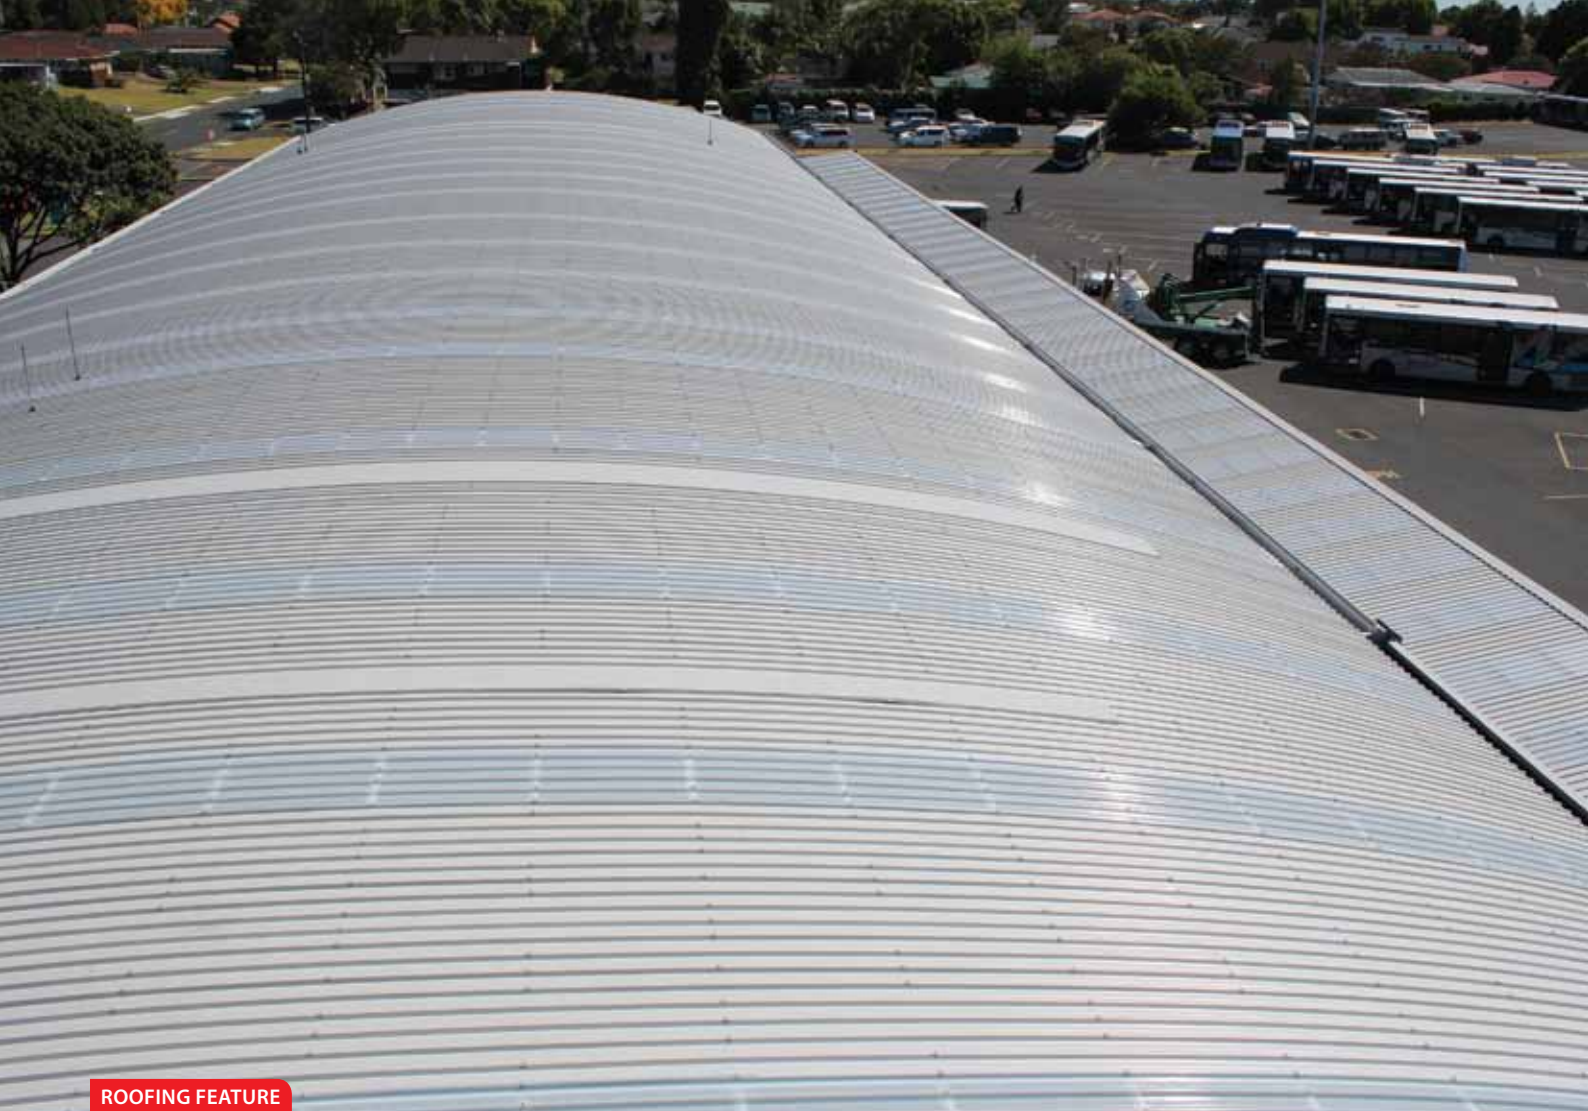
**Opposite page:**  
2200sqm of curved asbestos sheeting was removed at Wiri and replaced with Ribline® 960 .55 and Wonderglas GC clears.

The roofs at the Waka Pacific (Wiri) depot and Go West (Swanson) depot both leaked badly but the Wiri contract had the additional component of 45 year old, curved 26m SuperSix sheets covering a 2200sqm area to be removed. Fully compliant with asbestos removal requirements, Metro hired a machine featuring two 17m pallet lifts for taking off the asbestos so no man-handling

of the sheets would be required. As the SuperSix was removed, safety netting and then Ribline® 960 .55 was installed, along with some clear panel sections across the roof comprising Ampelite's Wonderglas GC (Opal) sheeting. The four roofers used a fall arrest system when required as the best means of protection from falls, edge protection being provided from deployment of Metro's two scissor lifts. Throughout the removal process Dowdell & Associates were monitoring contamination (including below where the roof was being stripped) and even they were surprised by the 0.00 reading recorded. For Rob's own peace of mind he included his own quality testing during the process.

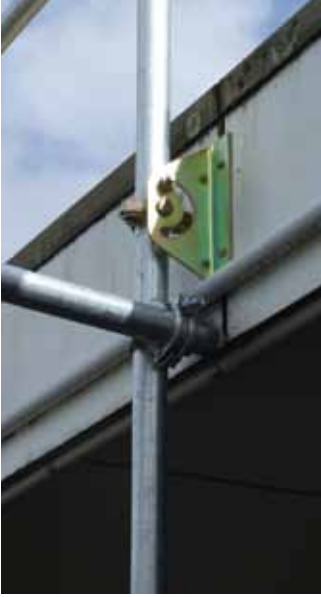
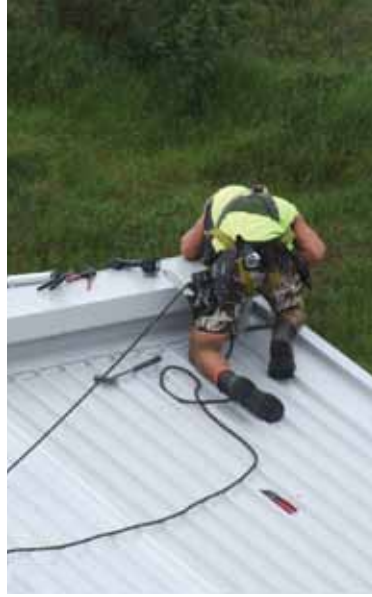
**This page:**  
Far left, new bracket system for anchoring the scaffolding; Metro employee on some detailing at the apex of the Swanson roof; right, Cool Tint sheeting has brought more light into the Swanson workshop.

Co's Premium package. Since launch of the guidelines, the company has also invested in fall edge protection scaffold, purchasing 250lm of 6m high material (enough to scaffold two houses) together with Metro's own bracket system designed to pull up under the soffit for anchoring of the scaffold. The Go West depot is suitably scaffolded for the remainder of the re-roof process on the office and administration block which will feature a mixture of 200lm of membrane plus some metal roofing.

"The Swanson roof, comprising Dimond 400 trough section, was 35 years old and leaking badly when our team commenced the re-roof", says Rob. Once again with a fully operational workshop beneath, the sheets were removed working across the roof space purlin-by-purlin, safety netting installed and then Ribline® 960 .55 across the 5000sqm roof area, interspersed with

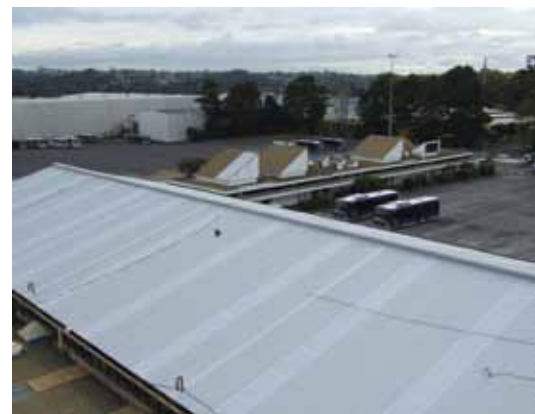
**Below left:**  
Metro is signed up to Hazard Co's Premium package; right, the Swanson depot roof nearing completion with the office/admin block in the distance soon to be re-roofed.
